STATE OF ALASKA  
Department of Transportation and Public Facilities  
2301 Peger Road Fairbanks, AK 99709

## Copper River Highway PEL Study Area

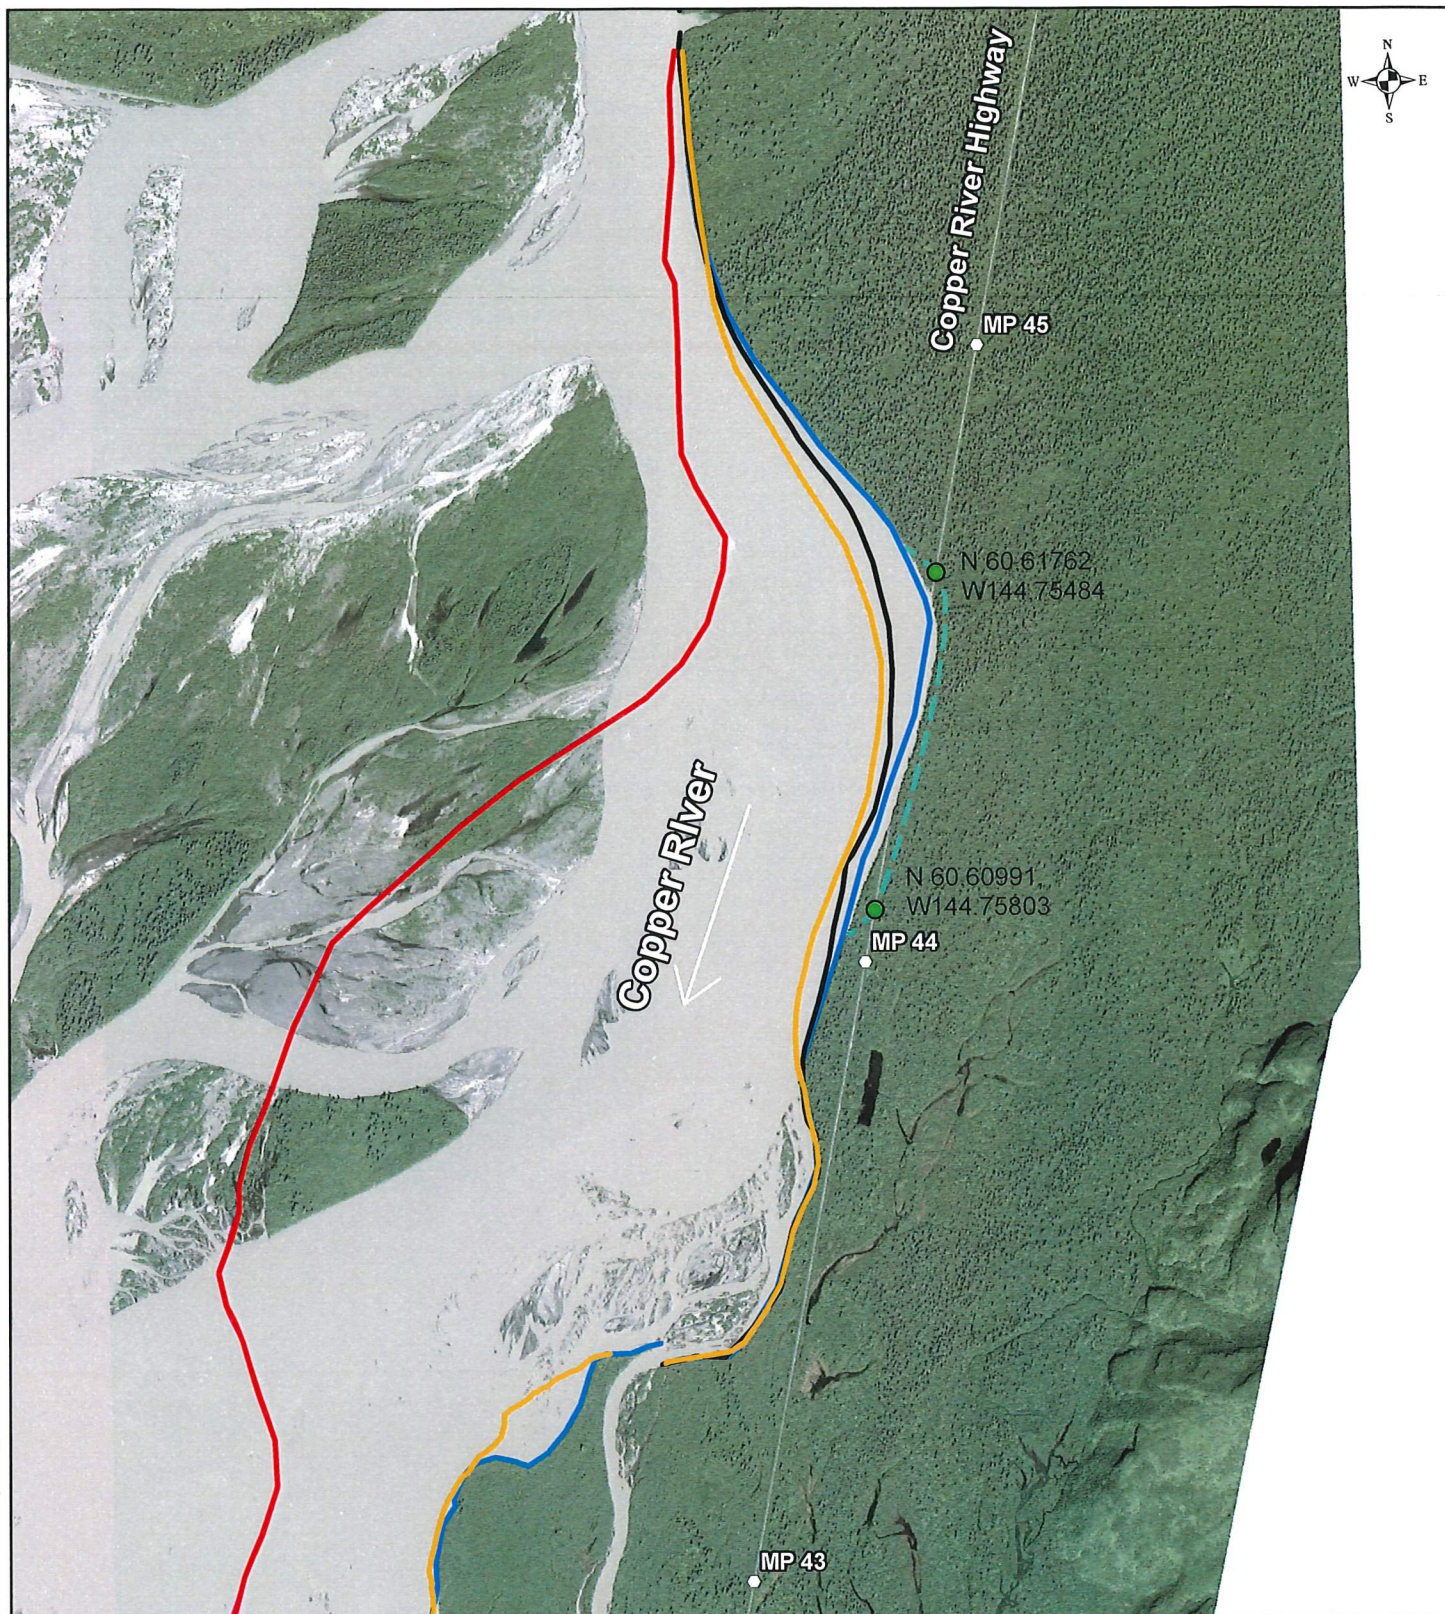
FIGURE 2

- July 1982 River Edge
- July 21, 2011 River Edge
- September 30, 2016 River Edge
- September 30, 2018 River Edge
- September 4, 2019 River Edge

### Chronology of Channel Migration Near MP 43-MP 45

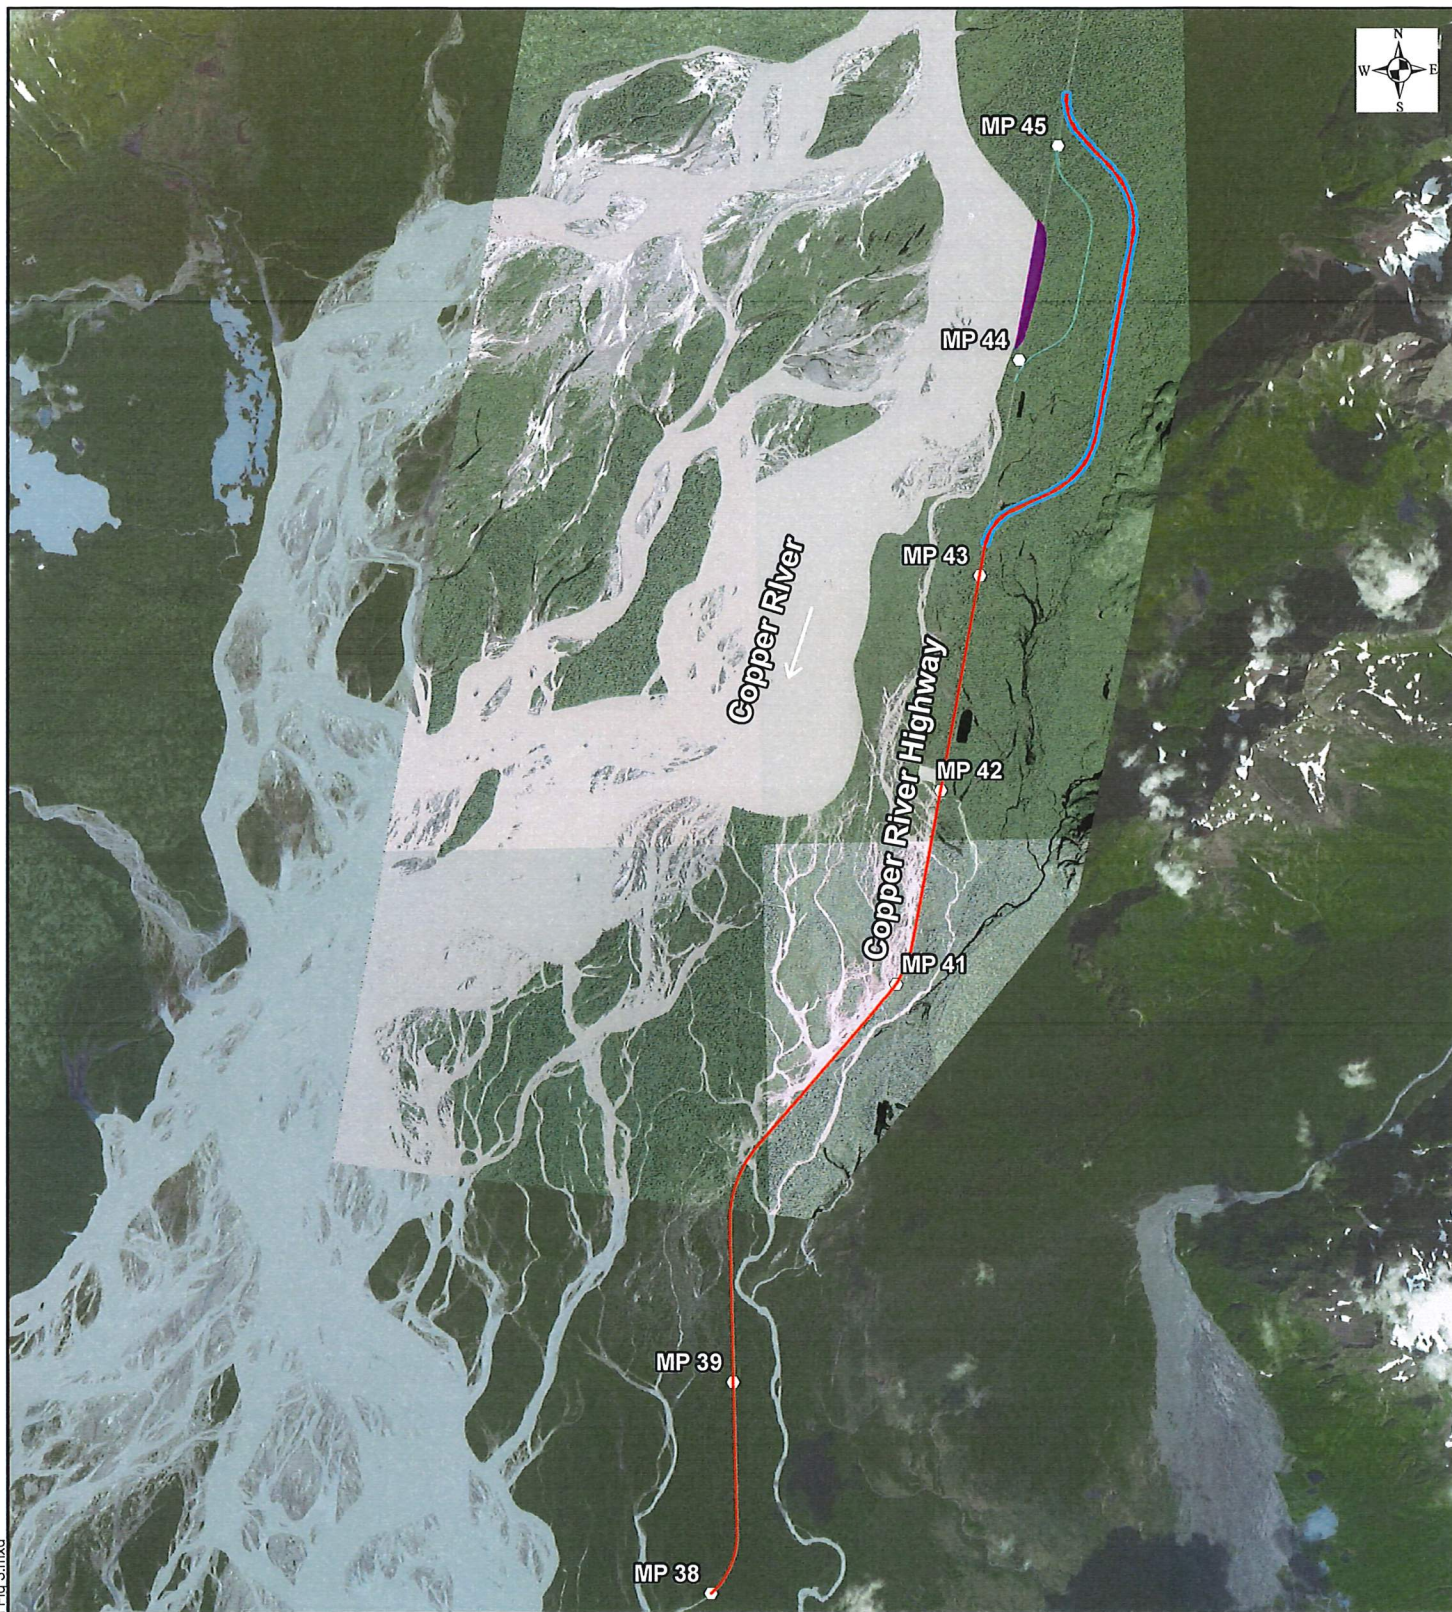
FIGURE 3

- Alt 1 - Reestablish ROW
- Alt 2 - Realign Road
- Alt 3 - Realign Road
- Alt 4 - Raise Grade of Road and Realign

## Preliminary Alternatives

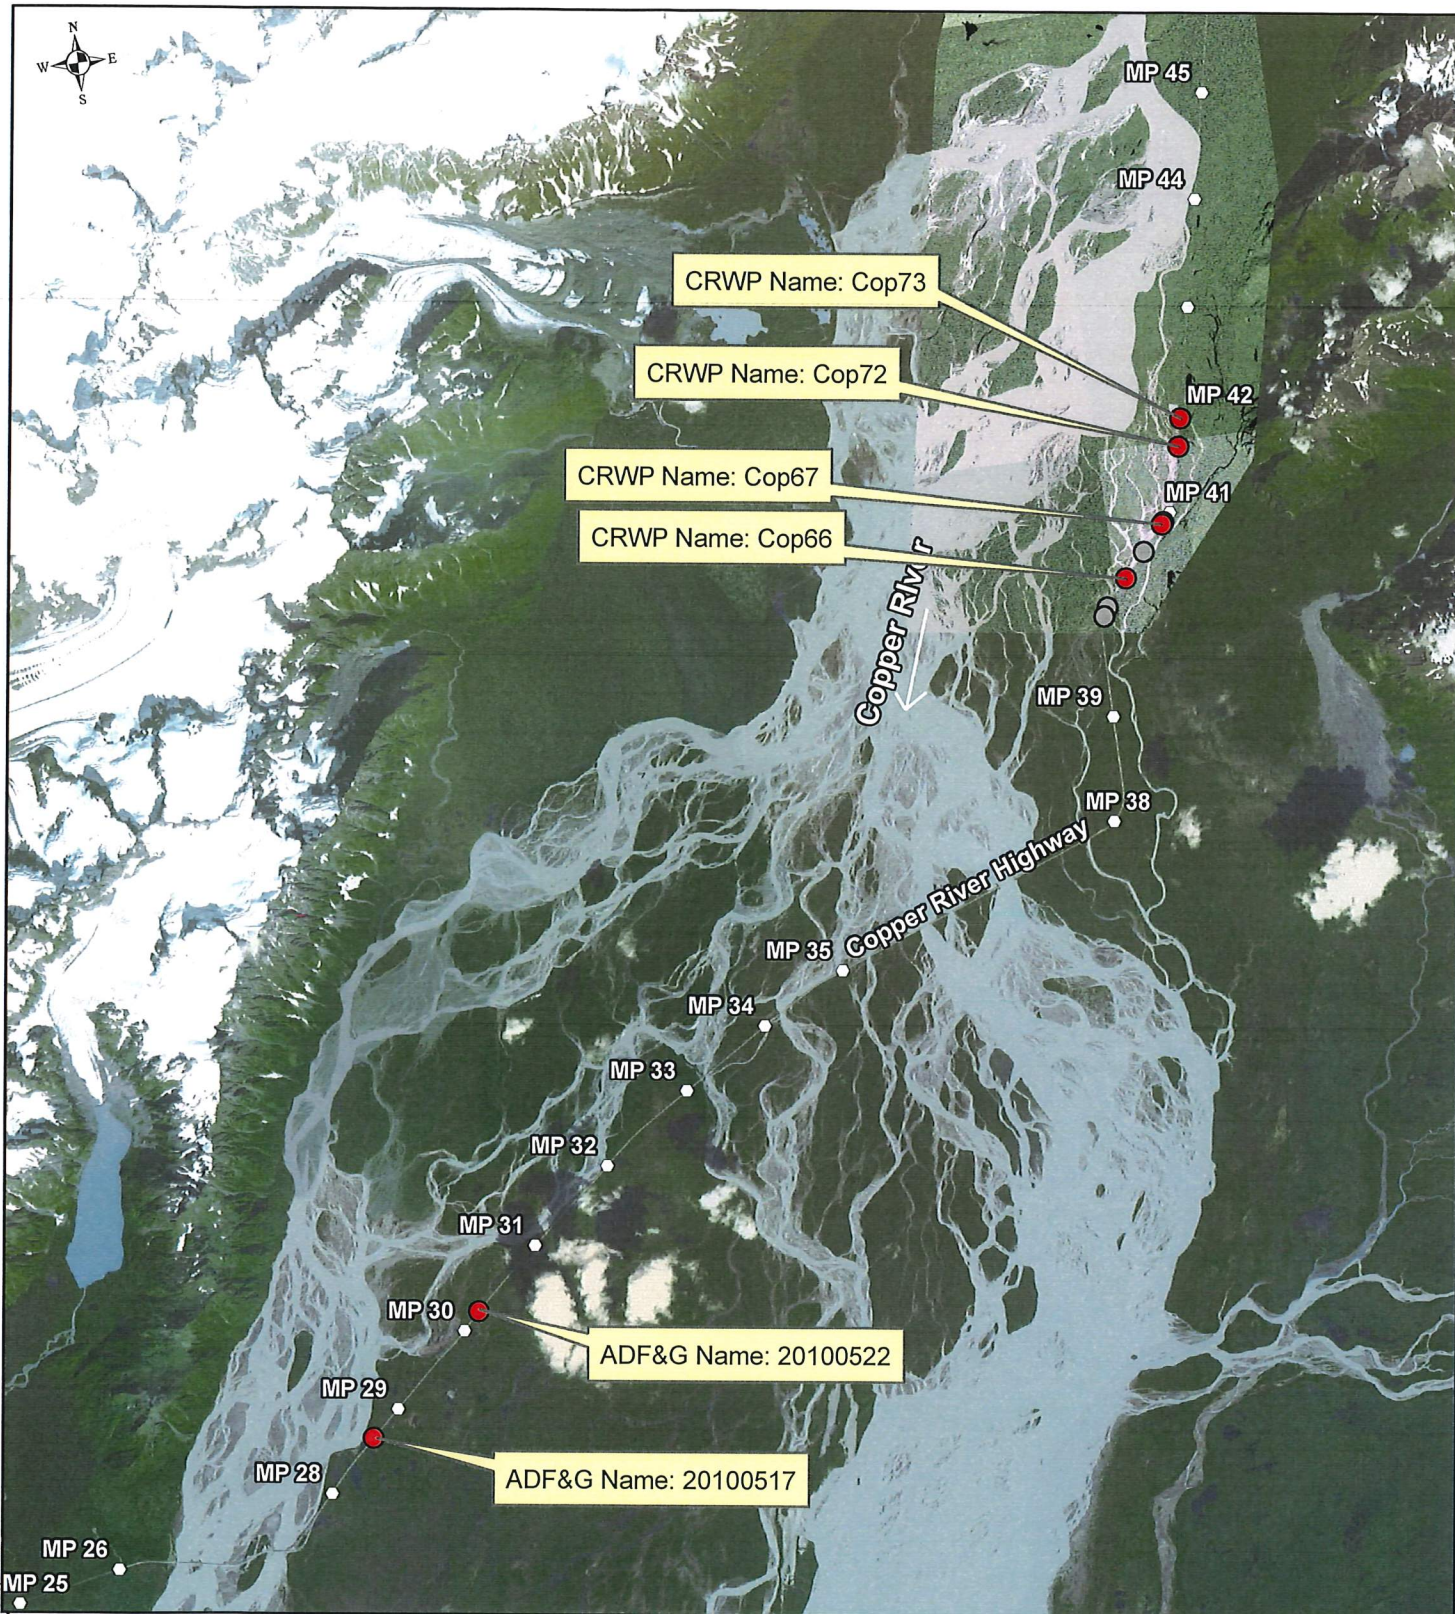
FIGURE 4

- Critical Culverts
- Culverts

## Fish Passage Culverts

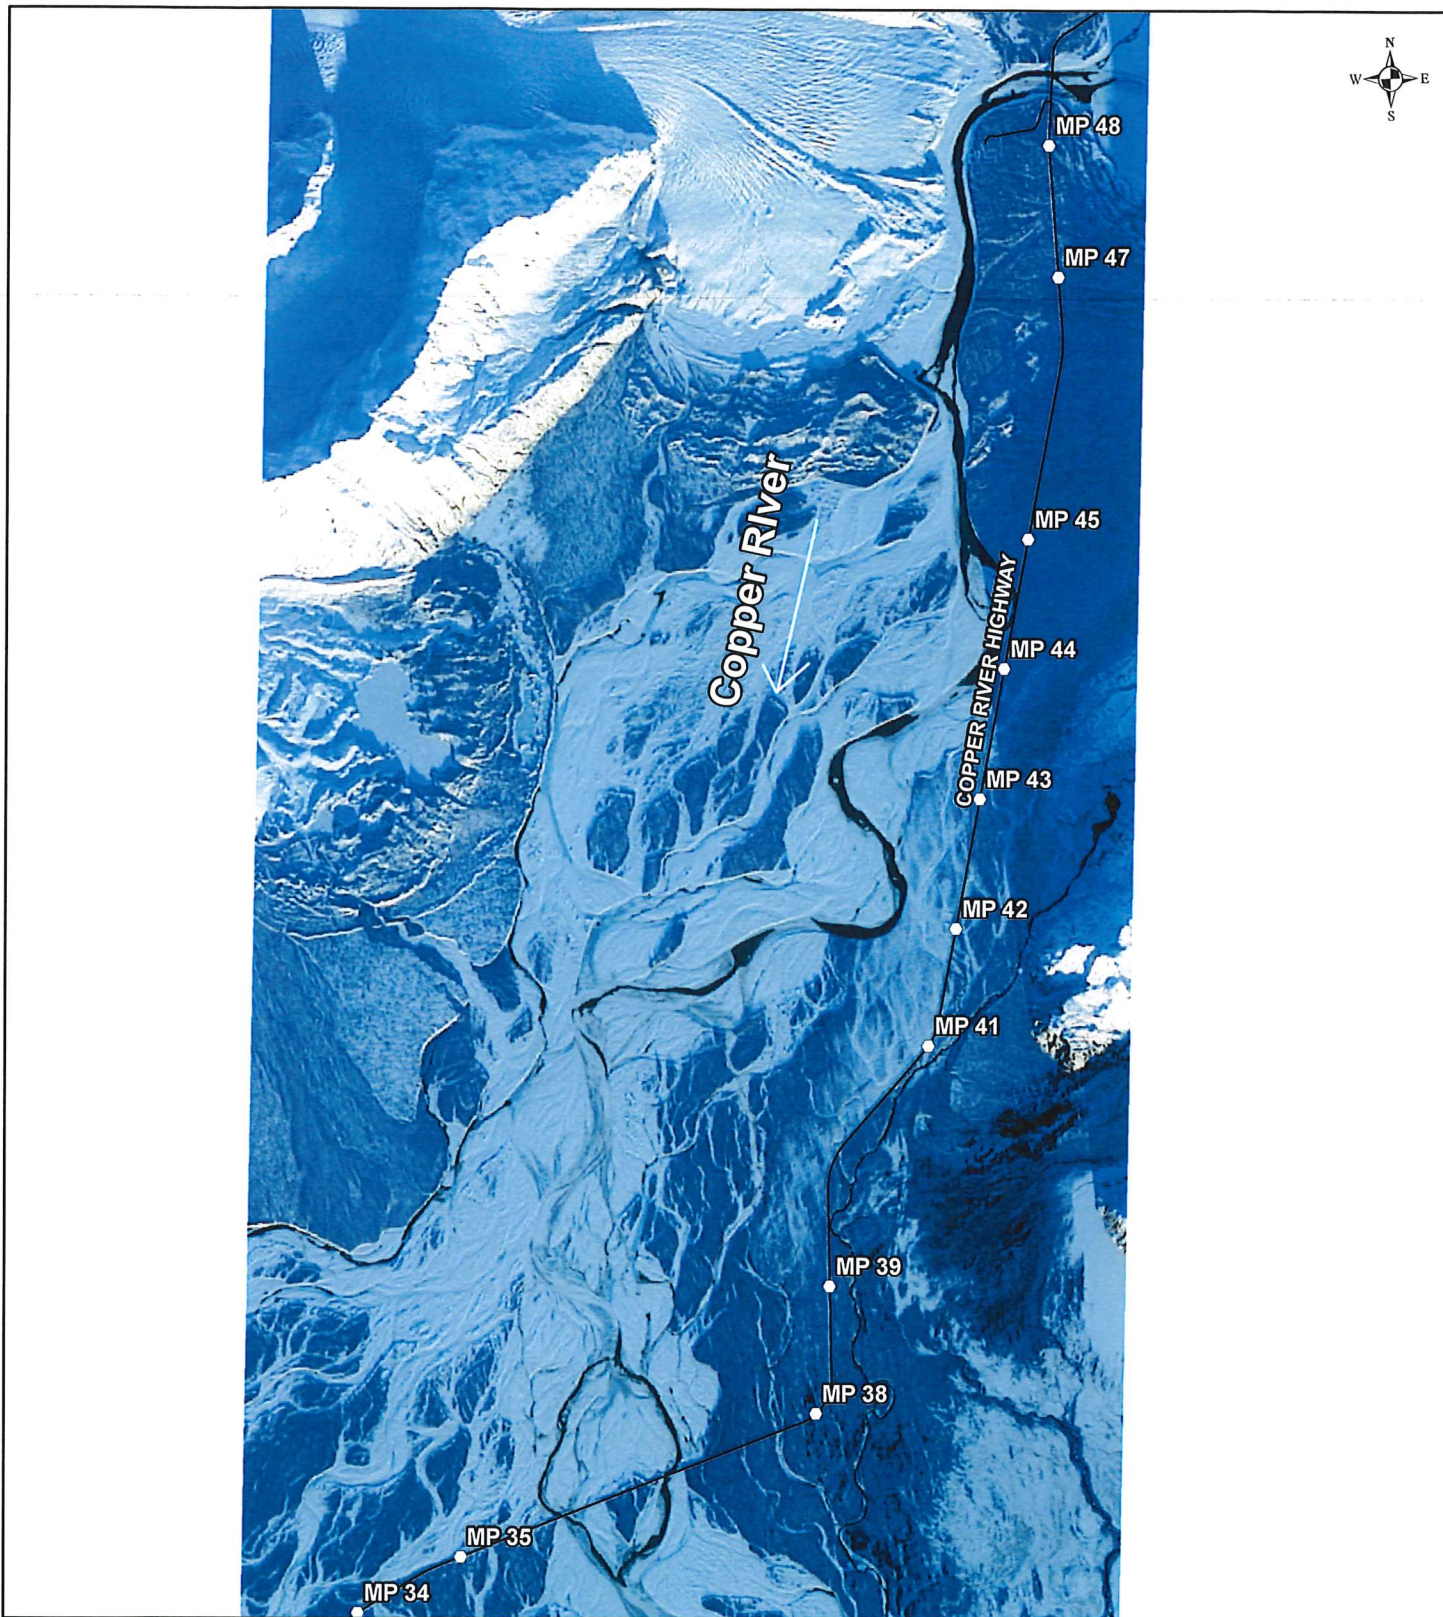
FIGURE 5

## Open Water During January 6, 2019

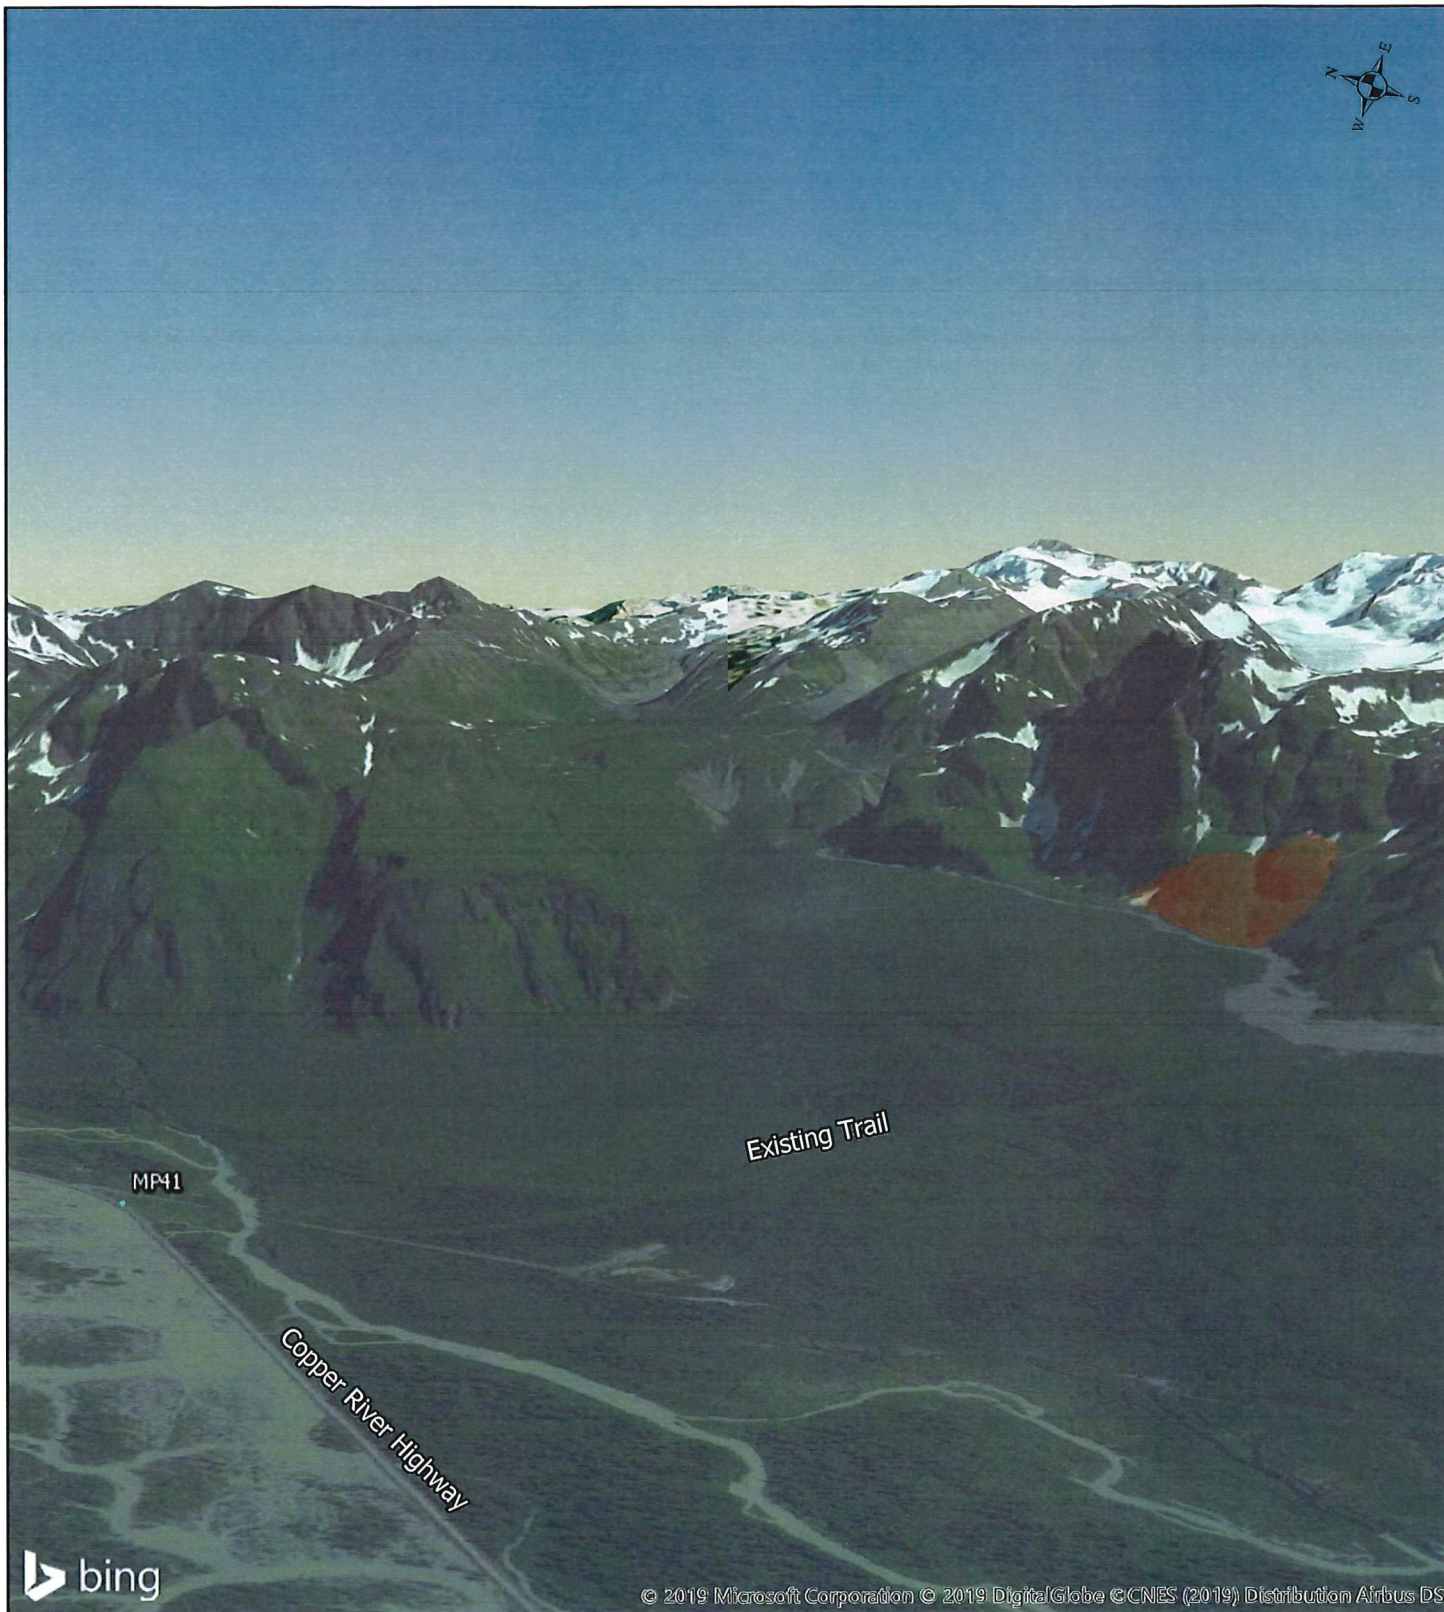
Figure 7

Granite Outcrop

Potential Material Site
